# Plasterboard Surface Inspection Defects Detection System

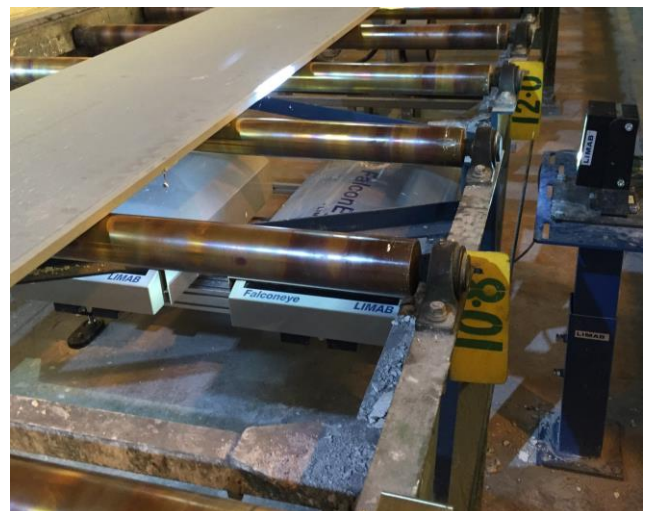
A powerful, angled LED light illuminates the board, and 2 high-speed grey scale cameras detect dents and bumps to identify periodic surface faults (signals a fault in the manufacturing process).
